## 2.0 ANALYSIS

## **2.5 Analysis of the chronological main events**

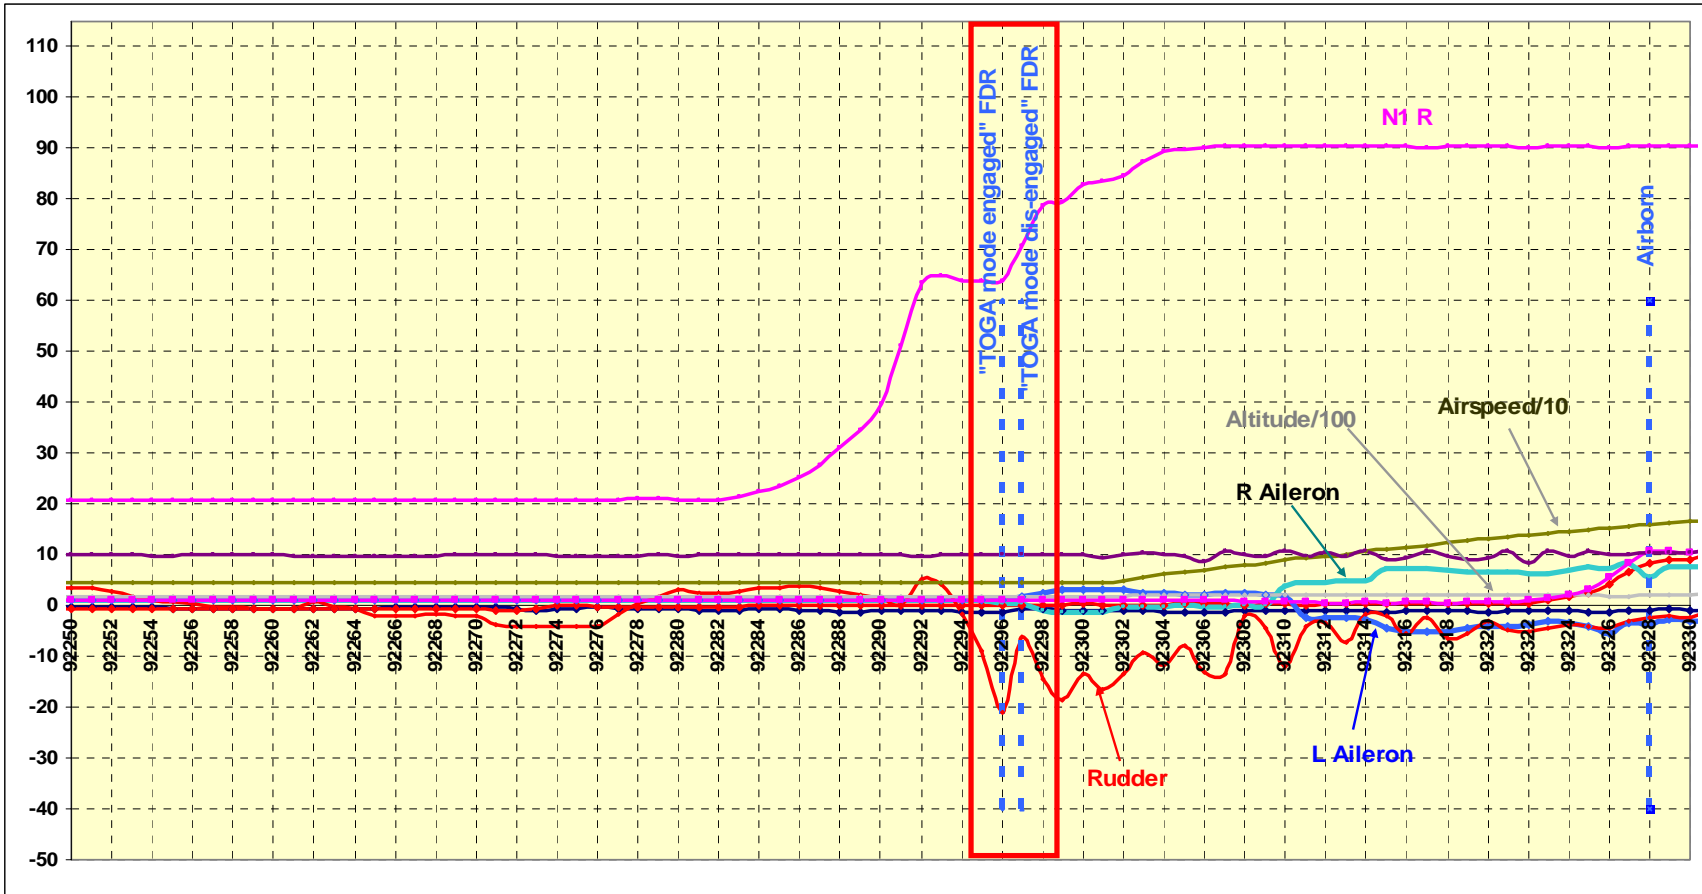
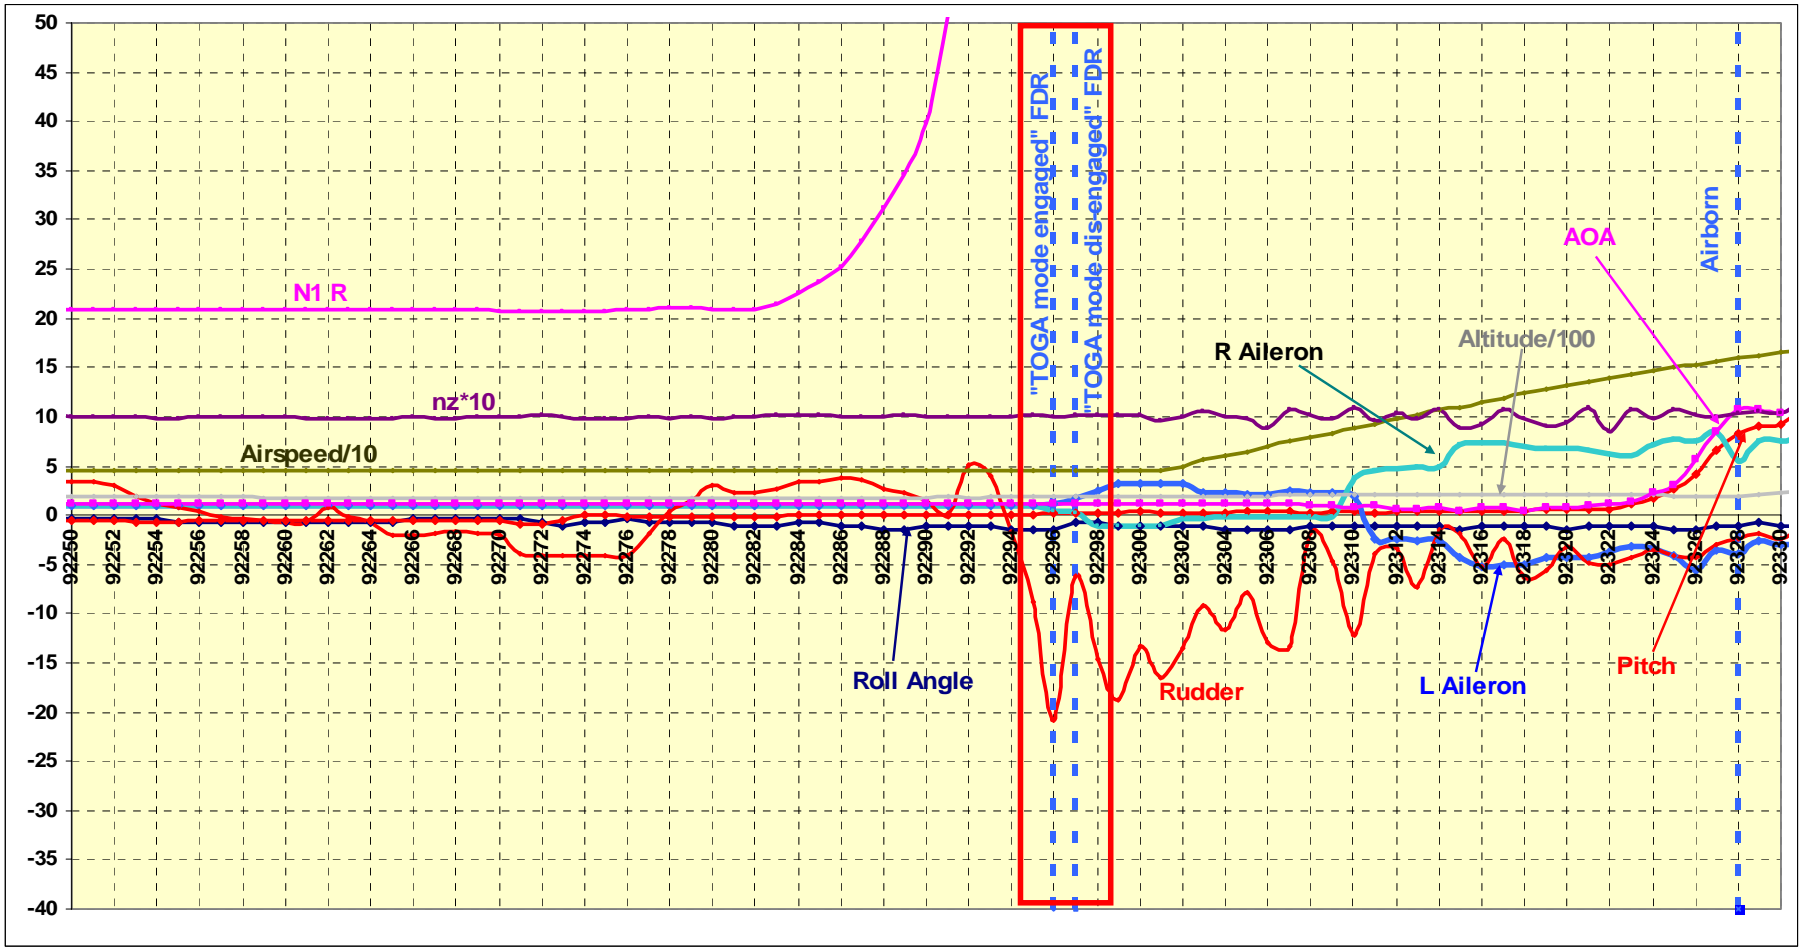
Figure 2.5.1.1a TO/GA Mode Disengages (FDR data)

FDR data shows TOGA on one side for only 1 or 2 seconds, other side unknown (all 13 flights with both A and B for different flights): for the accident flight, the TO/GA Mode was engaged at 92296 second, and was disengaged at 92297 second

- FCC takeoff mode has not been operating properly for the entire 25 hours recorded on the FDR. Based on FDR data available, the cause for this either a bad squat switch (landing gear compressed) input to one FCC or a bad landing gear position indication to one FCC. In either case, the results is that pressing the TOGA button during takeoff would result in one FCC entering takeoff mode while the other enters go-around mode. This disagreement is detected and results in both FCCs dropping the TOGA mode<sup>2</sup>.

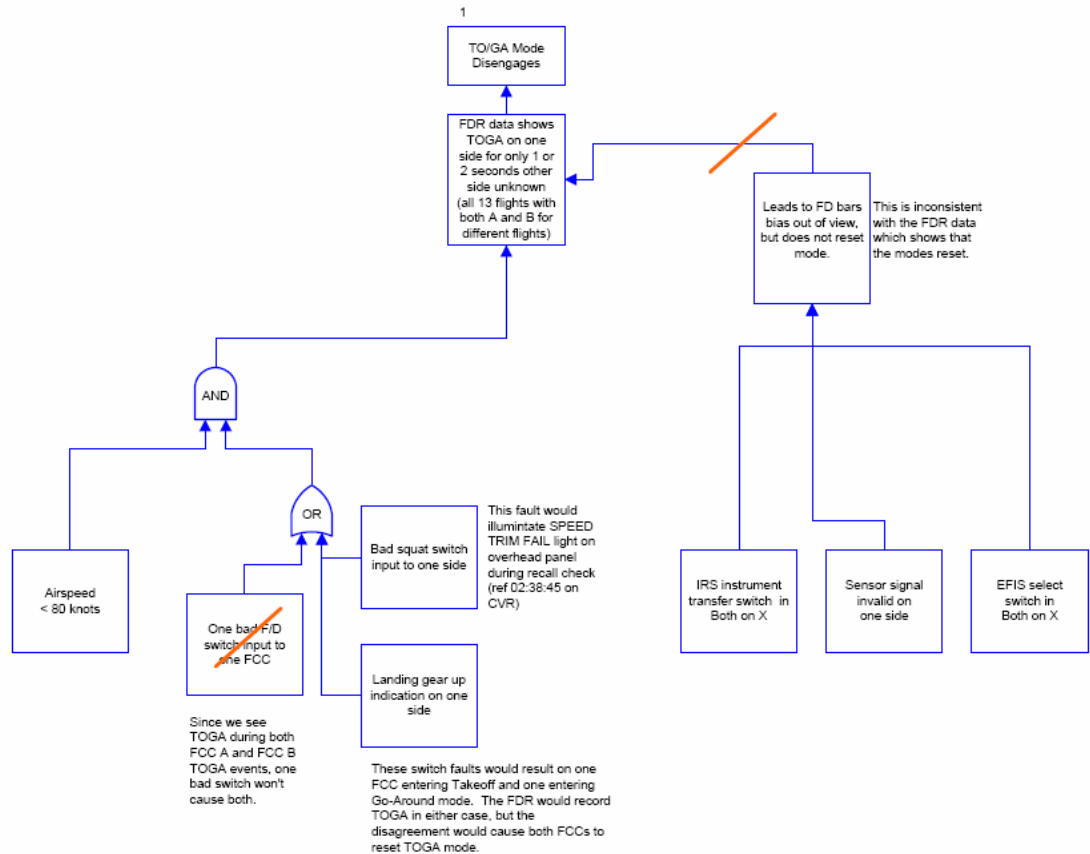
Fig 2.5.1.3.a TO/GA Mode Disengage Logic

- Since we see TOGA during both FCC A and FCC B TOGA events, one bad switch won't cause both. That makes the condition of "One bad F/D switch input to one FCC".
- The condition of {(IRS instrument transfer switch in Both on X) + (Sensor signal invalid on one side) + (EFIS select switch in Both on X)} leads to FD bars bias out of view, but does not reset mode. This is inconsistent with the FDR data which shows that the modes reset.
- Regarding the "Landing gear up indication on one side", the switch faults would result on one FCC entering Takeoff and one entering Go-Around mode. The FDR would record TOGA in either case, but the disagreement would cause both FCCs to reset TOGA mode.
- Regarding the "Bad squat switch input to one side", this fault would illuminate SPEED TRIM FAIL light on overhead panel during recall check. (ref 02:38:45 on CVR)

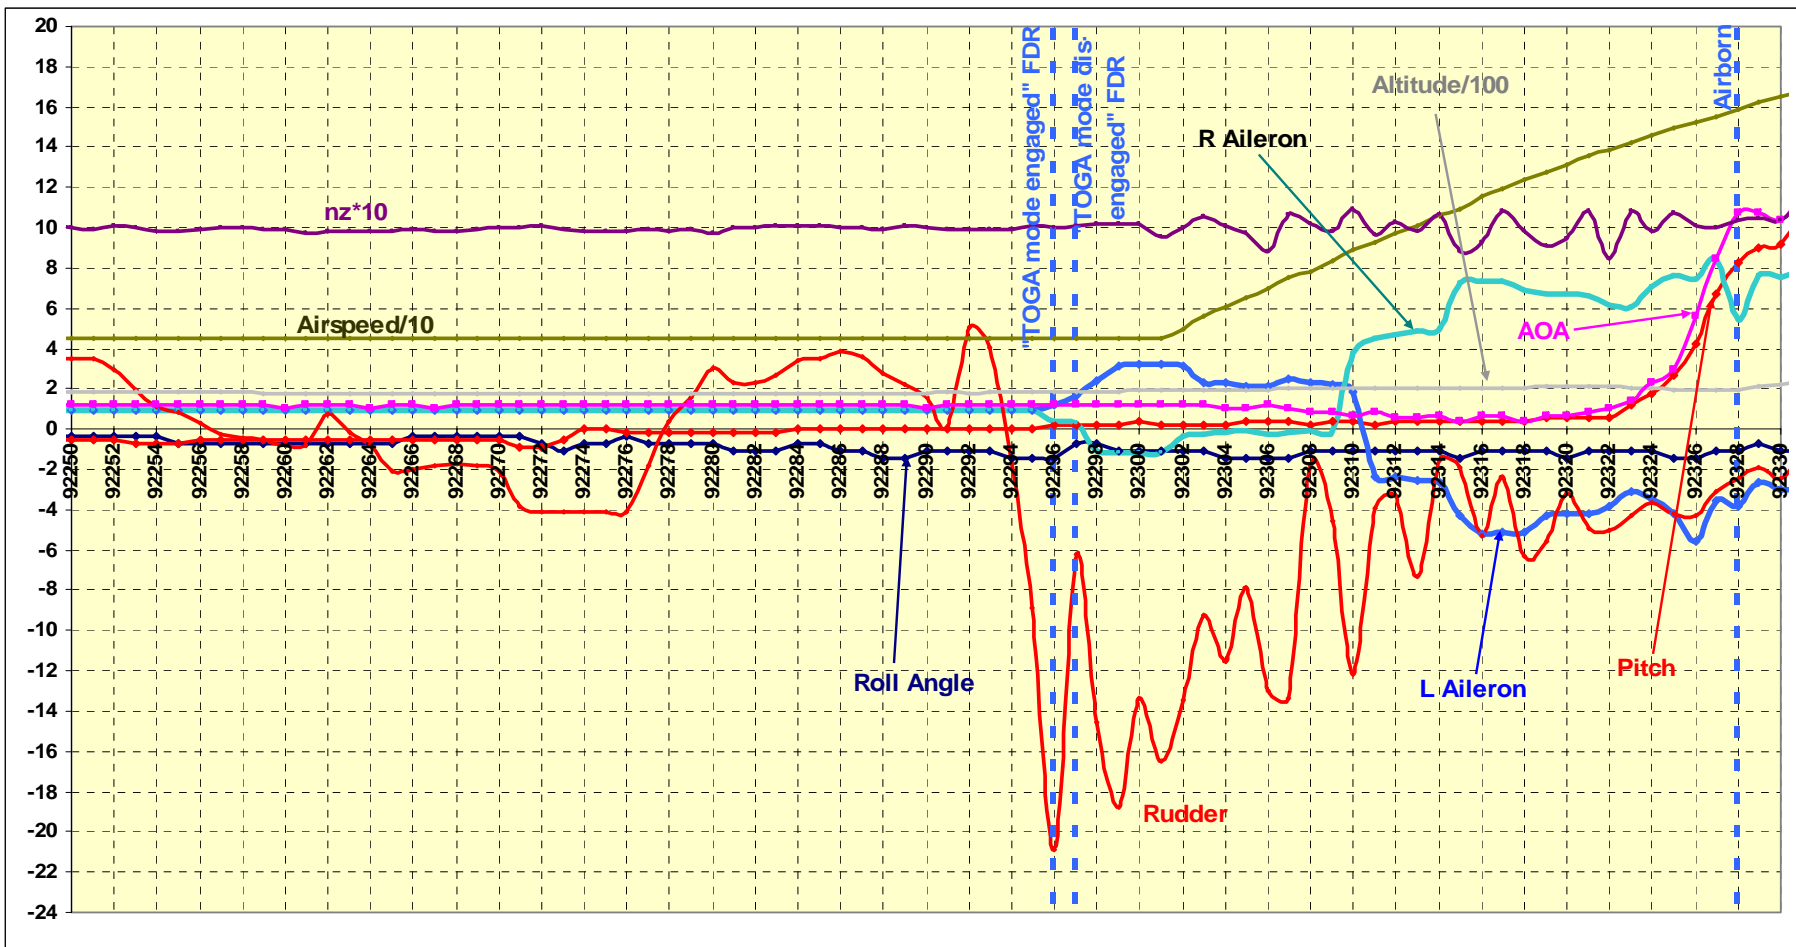
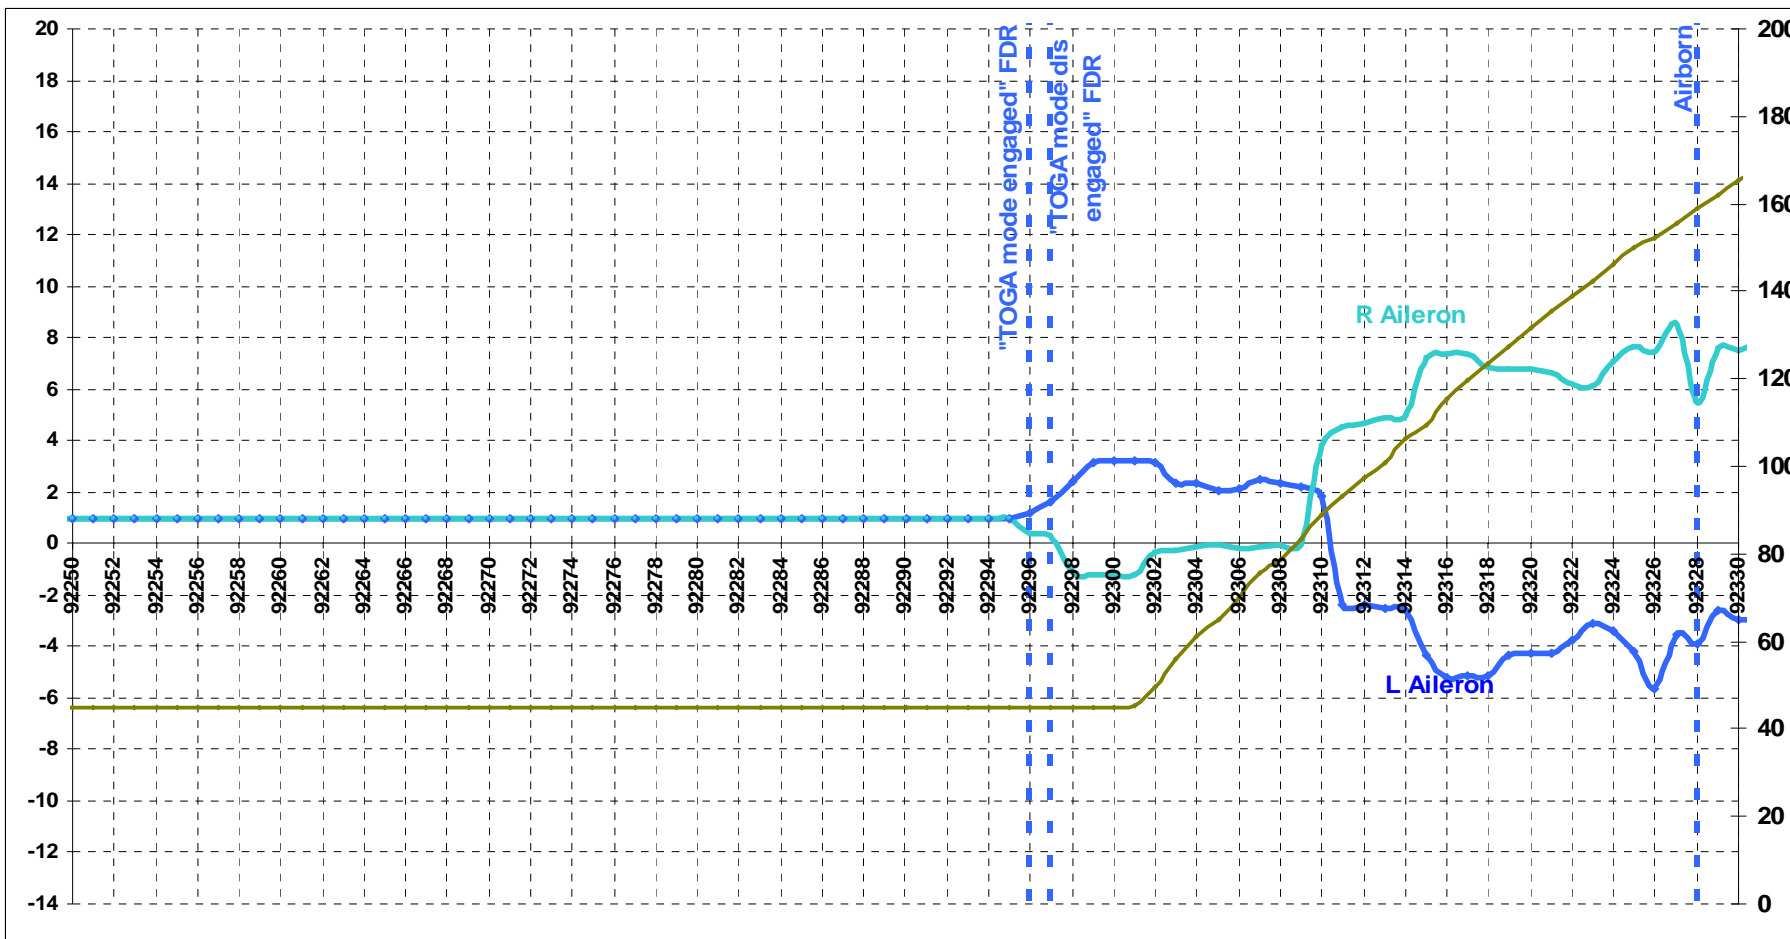
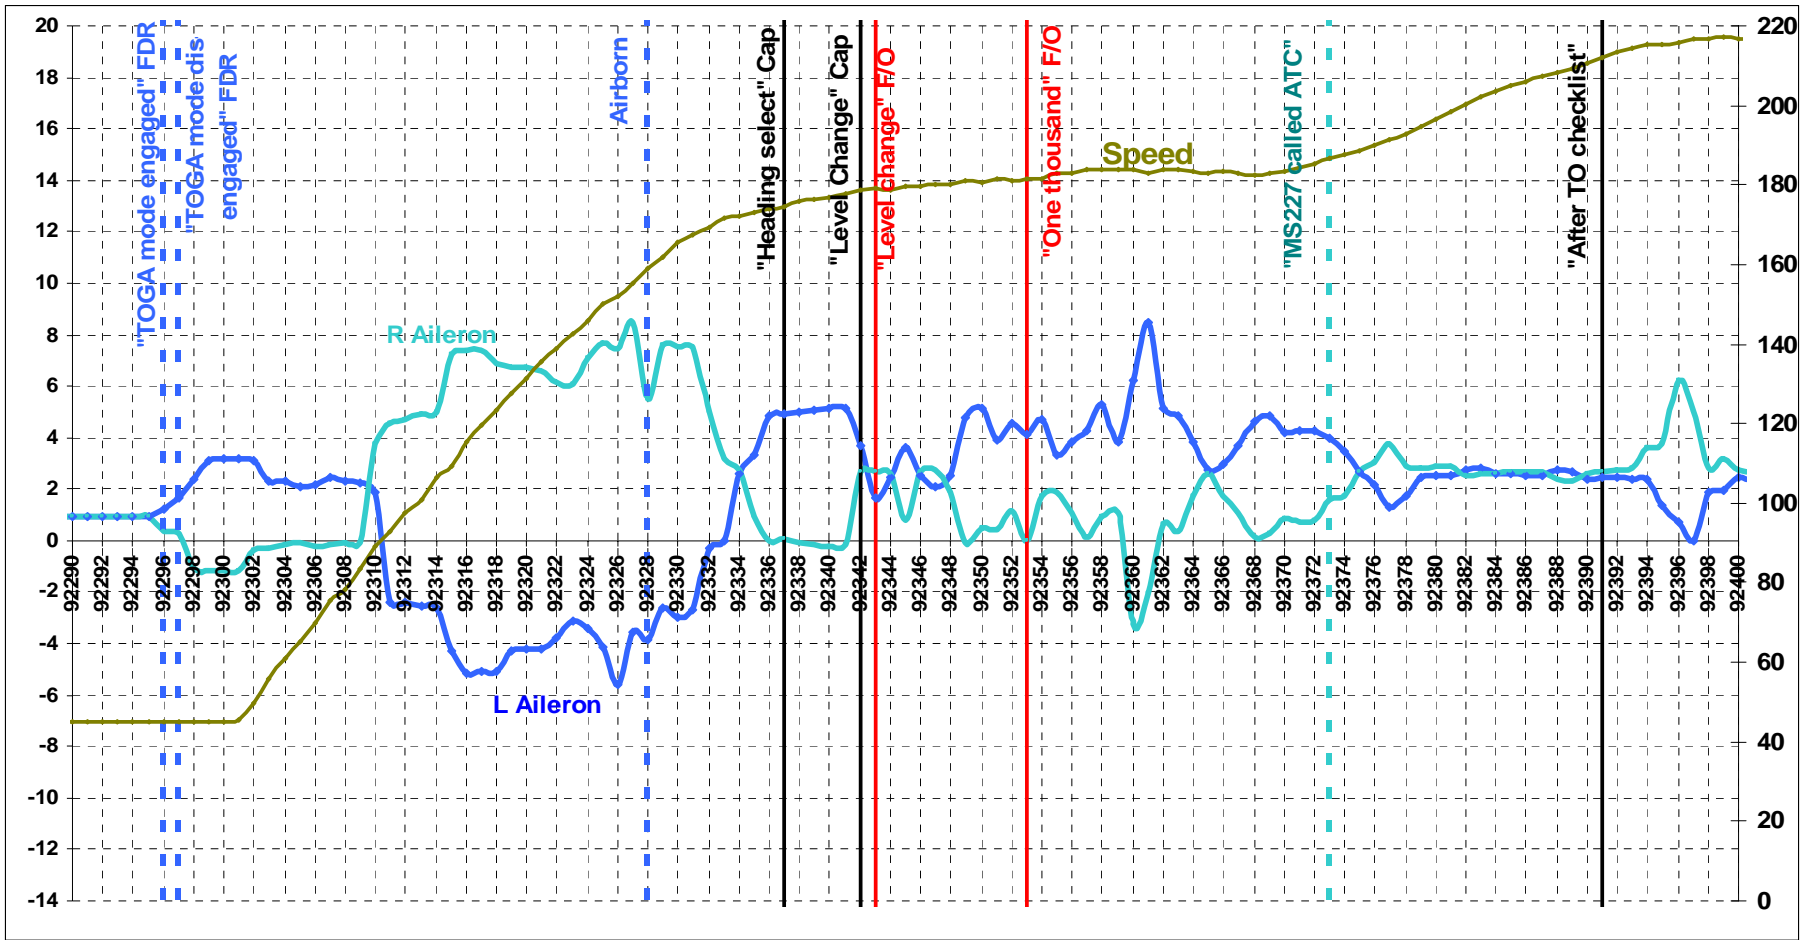
Figure 2.5.2.1a Aileron Movement during Takeoff event

- The wind condition was 280/08 at Take Off. The aircraft was taking off from runway 22R, with a relative wind direction of about 60 degrees. The cross wind component was about 6.9 kts blowing from the right side of the airplane.

- Aileron movement direction during Takeoff is consistent with the wind condition existing during the Takeoff.
- Aileron bias change could be related to change in airplane speed.

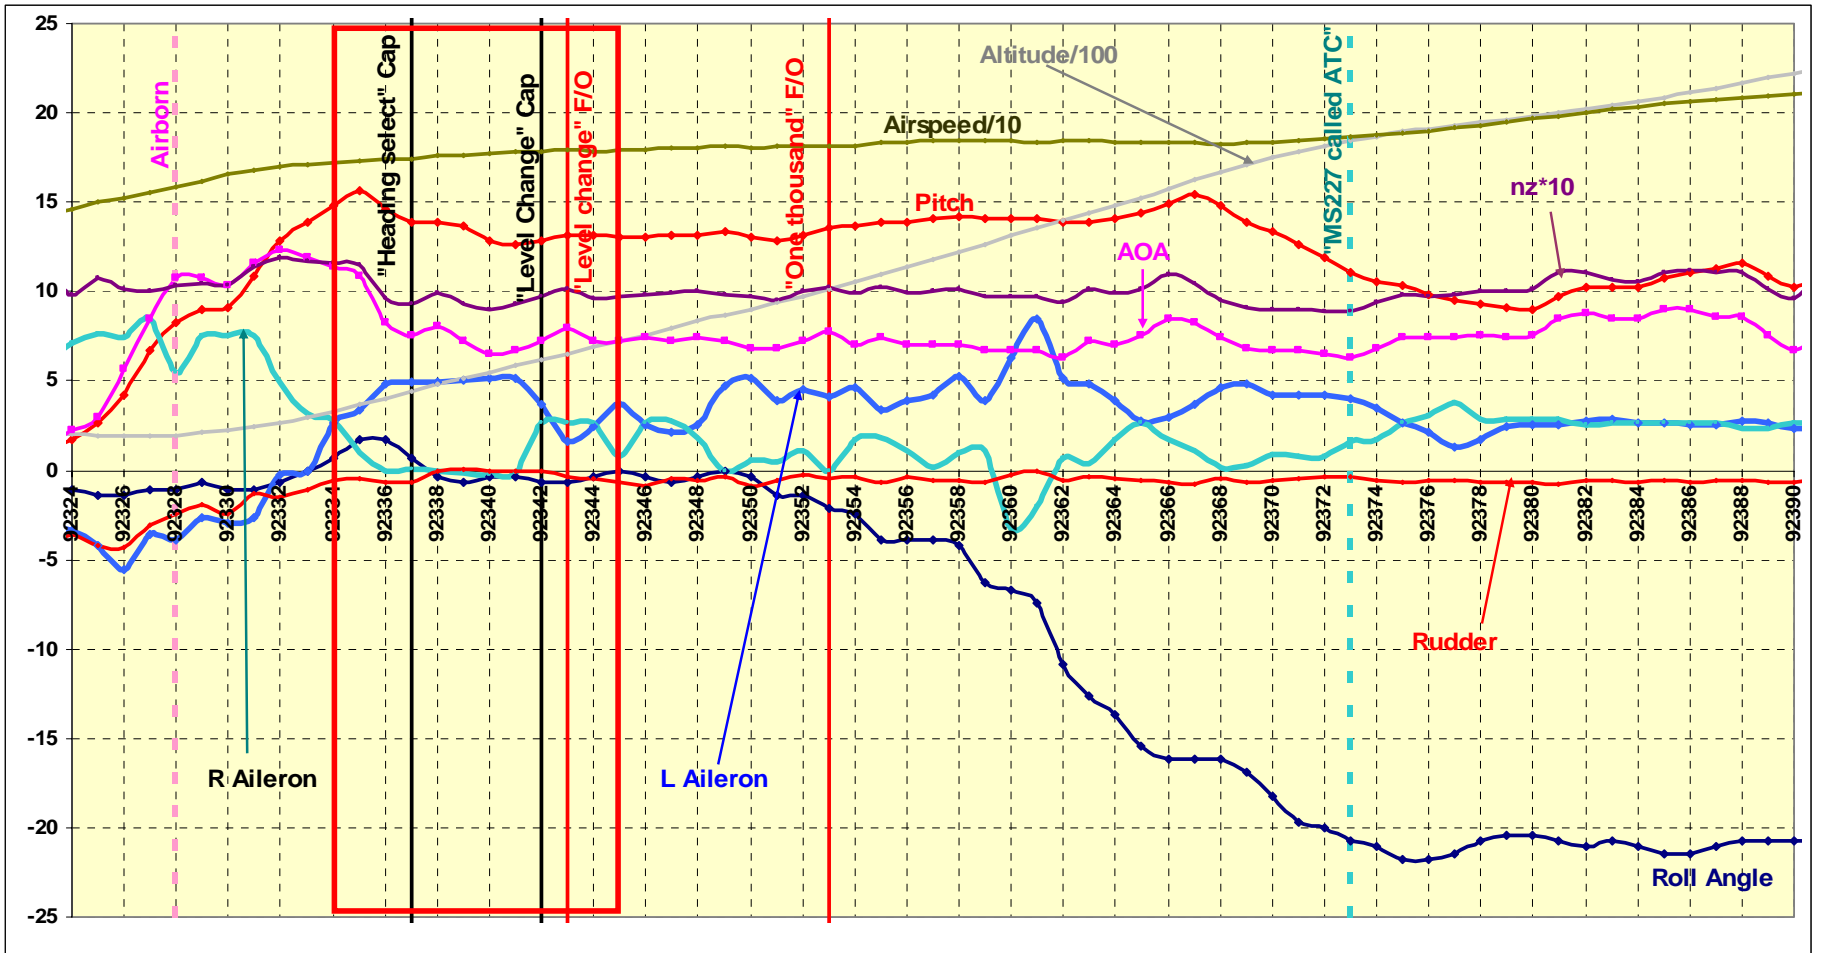
Figure 2.5.3.1 FD Modes (Pitch & Roll) Re-Engagement event

- At 42:48 Captain called for Level Change
- At 02:42:49 First officer confirmed “Level Change, MCP speed, N1 Armed sir”
- At time 2:42:50, FDR data indicates Level Change mode engaged (Frame 92344)  
(Setting “Level Change” mode would restore the FD pitch command bar).

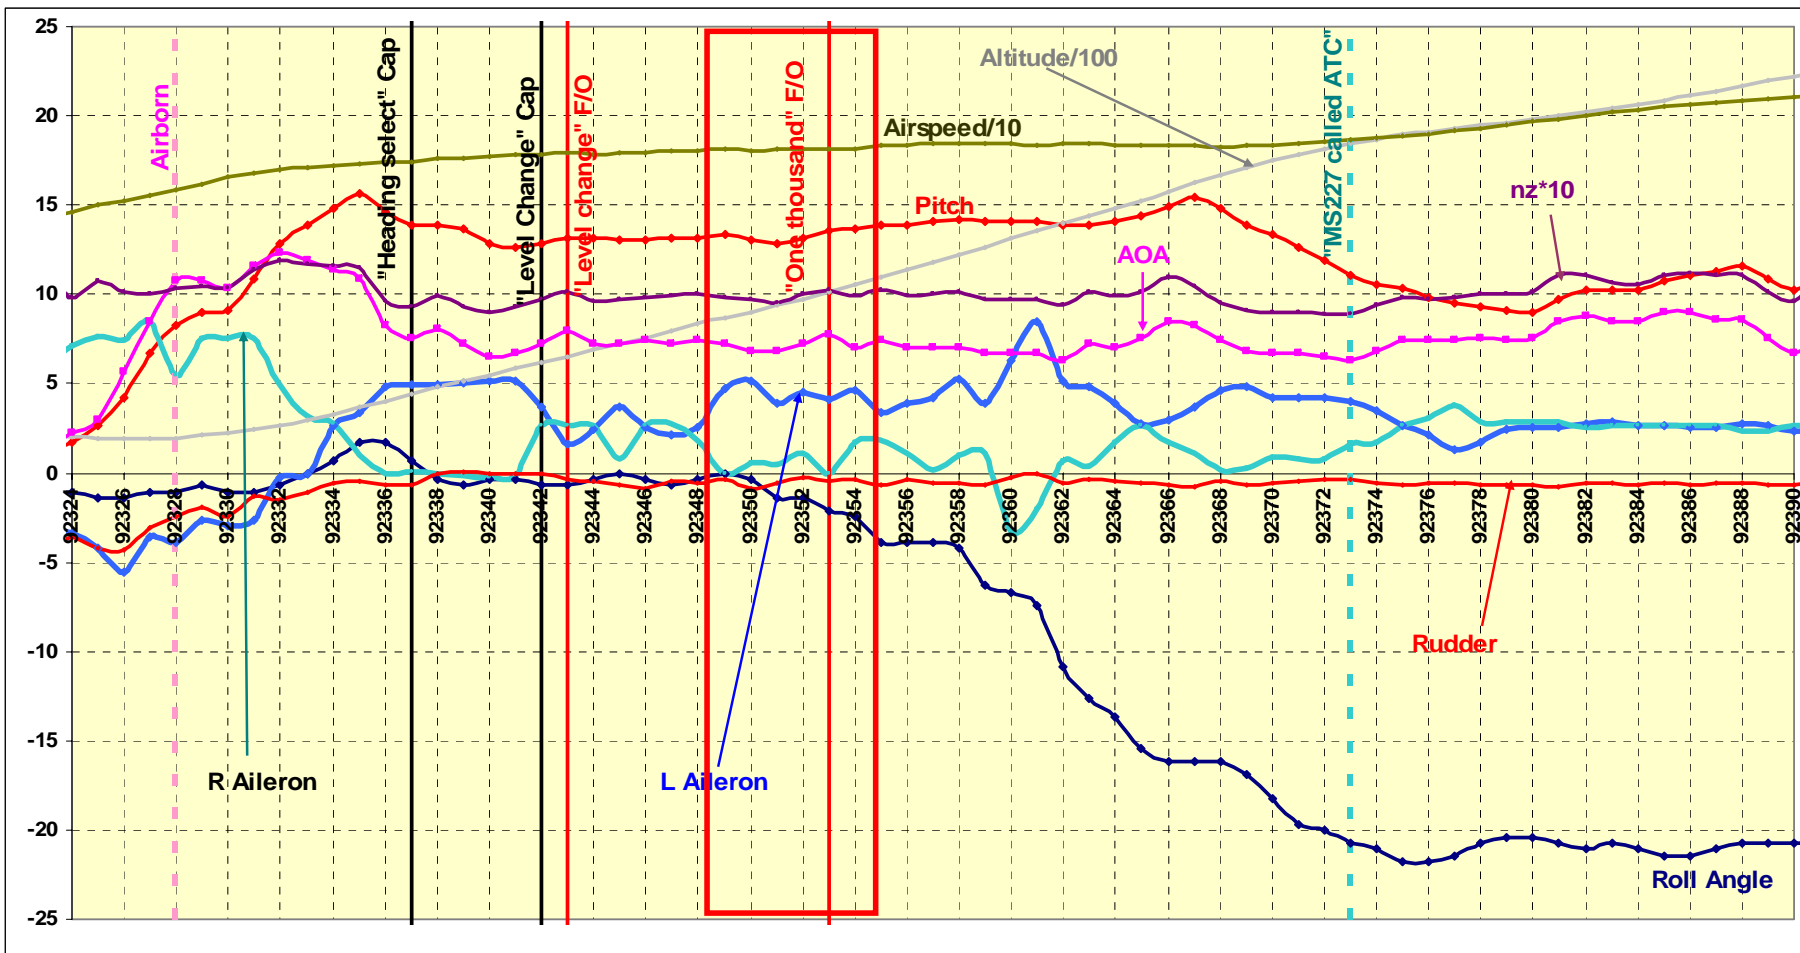
Figure 2.5.4.1 Roll Left and Left Turn Begun event

Note: Though not published, a 270° turn is the customary night-time departure patterns from SSH and would have been familiar to the crew. The direction of turn (left or right) depends upon the runway used, but should be over the Red Sea. In fact, the FDR records that the accident crew successfully flew the mirror image pattern about 24 hours previously (right turn of 266° from runway 4).

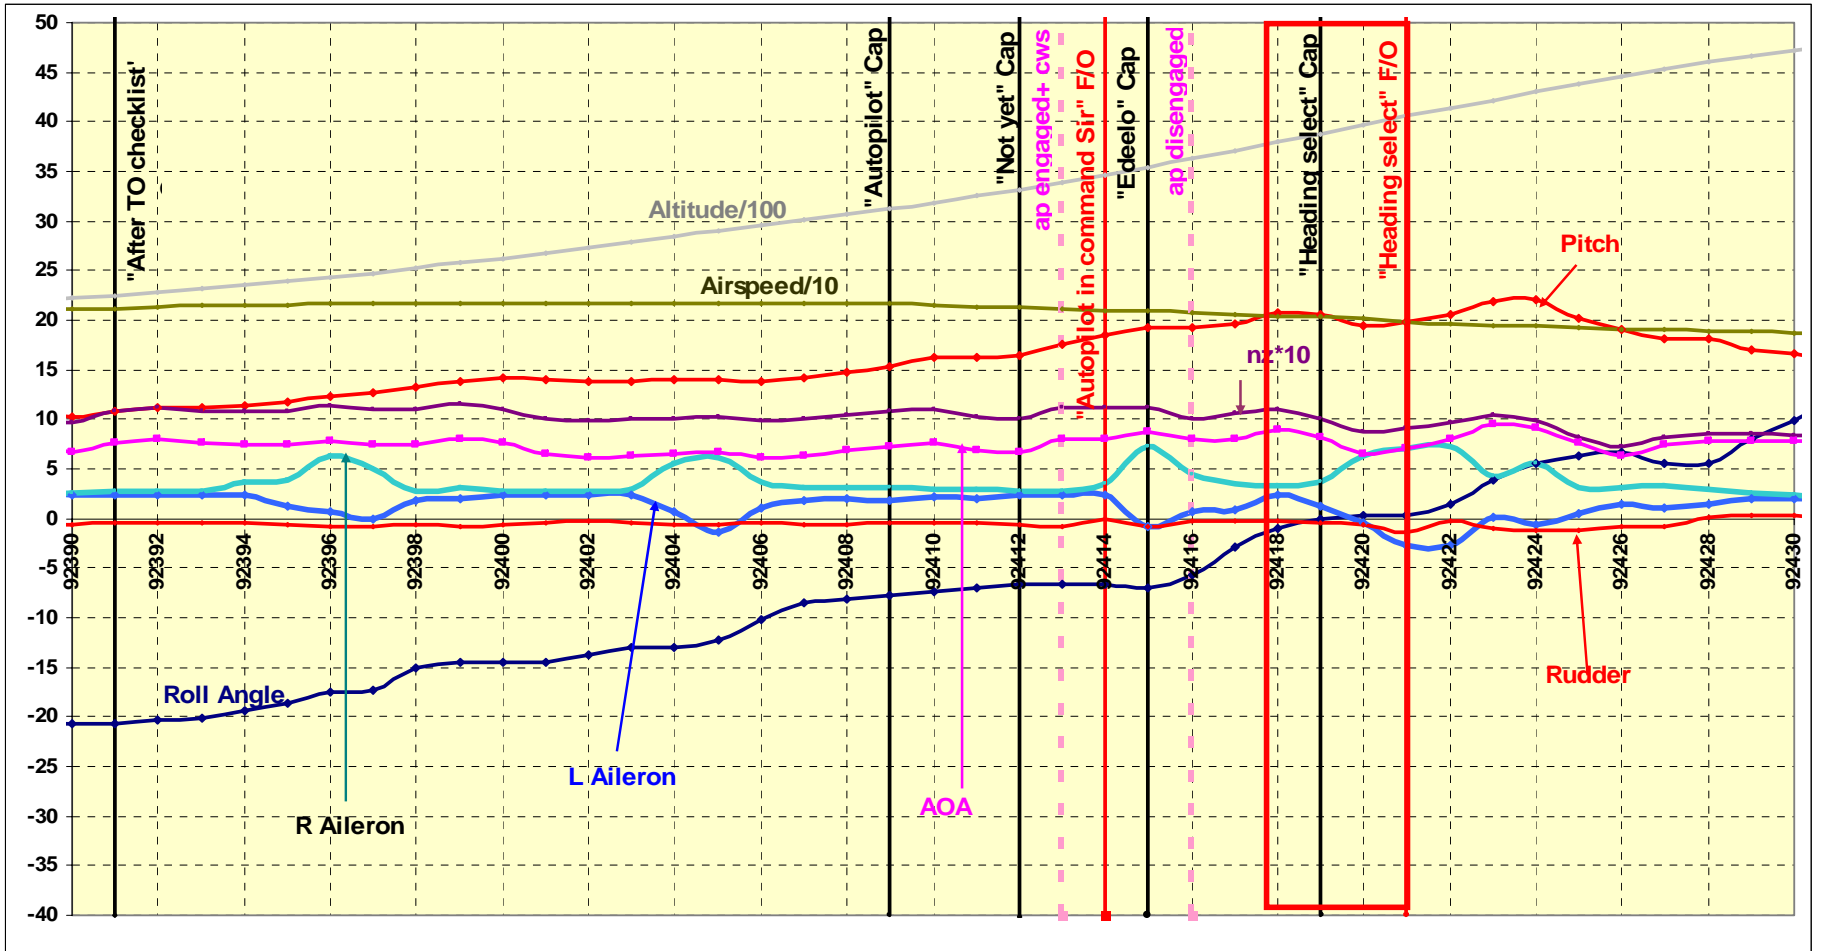
Figure 2.5.5.1 Roll back towards wing level event

Based on the FDR data and at almost time frame 92419 second, the airplane left turn stopped and the wings became in level condition

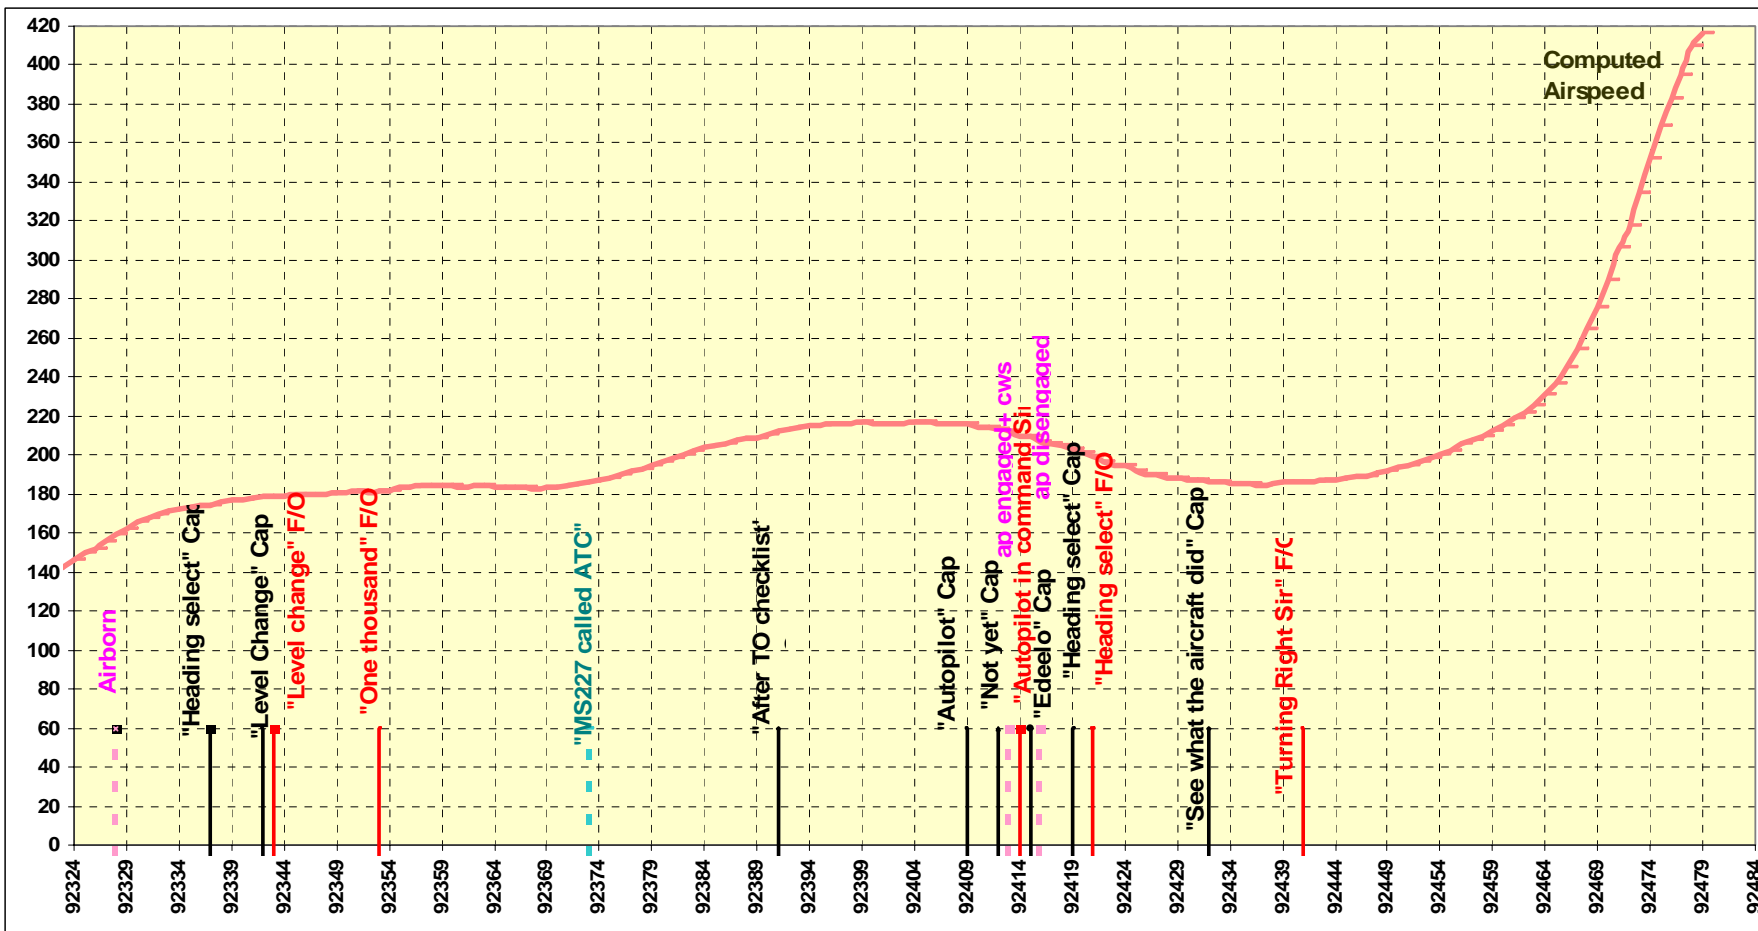
Figure 2.5.6.1 Pitch up and airspeed decay

Based on the FDR data the speed reached 217 Kt at time frame 92405 (seconds), but the speed decreased to 184.5 Kts at 92437.

1. Pilot Wanted to Gain Altitude Quicker (Intended Maneuver)  
This possibility may be supported by the fact that the airplane should intercept the VOR radial at a minimum of 11,000 ft
2. Pilot Following Erroneous FD (intended)  
There are not enough data to rule in or rule out this probability
3. Relaxation of Control in Out of Trim Condition (Unintended Maneuver)  
The results from the M-CAB tests match with FDR
4. Autopilot Fault (Unintended Maneuver)  
This condition might be ruled out. This event started prior to AP Engagement (based on FDR data)
5. Stab Trim Fault (Unintended Maneuver)  
This condition might be ruled out. Based on FDR data, the stabilizer did not show abnormal behavior throughout the flight.
6. Pilot pulling on the control column (unintentional)

In all cases, this event does not have direct relation to the accident

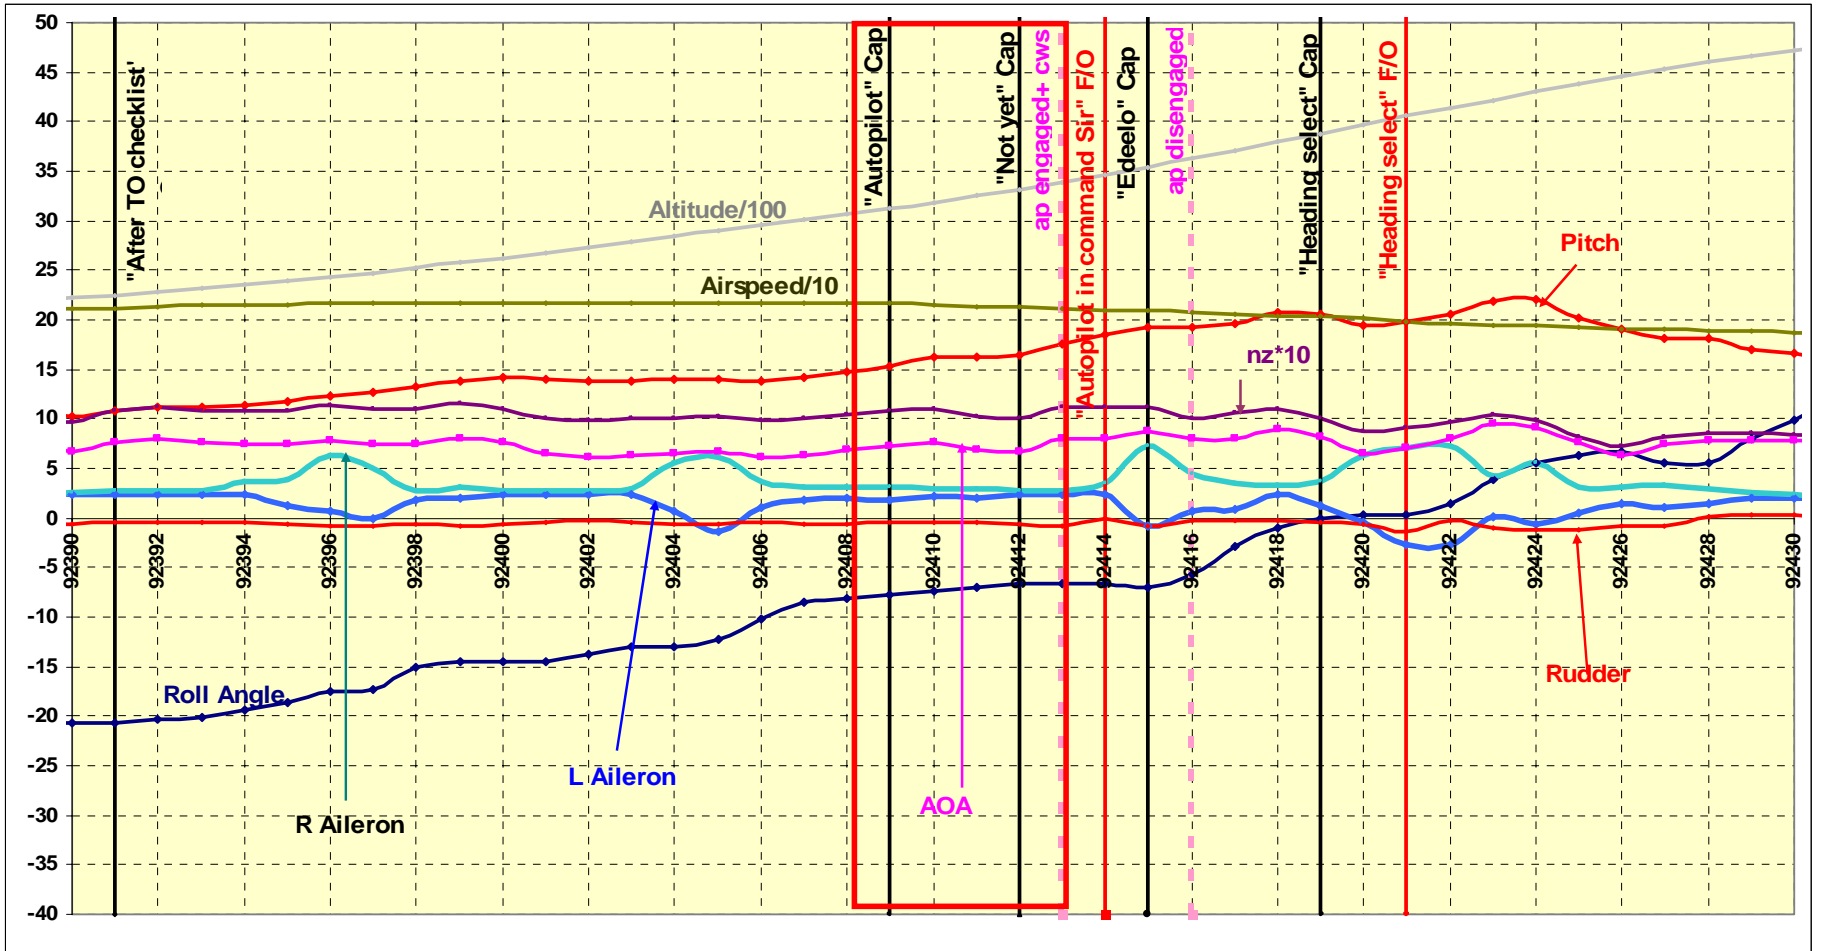
Figure 2.5.7.1 Autopilot engage sequence

Based on the CVR data, the Captain announced 'Autopilot' at 92409, followed by "Not yet" at 92412. At 92413 FDR showed A/P engaged+ CWS-R

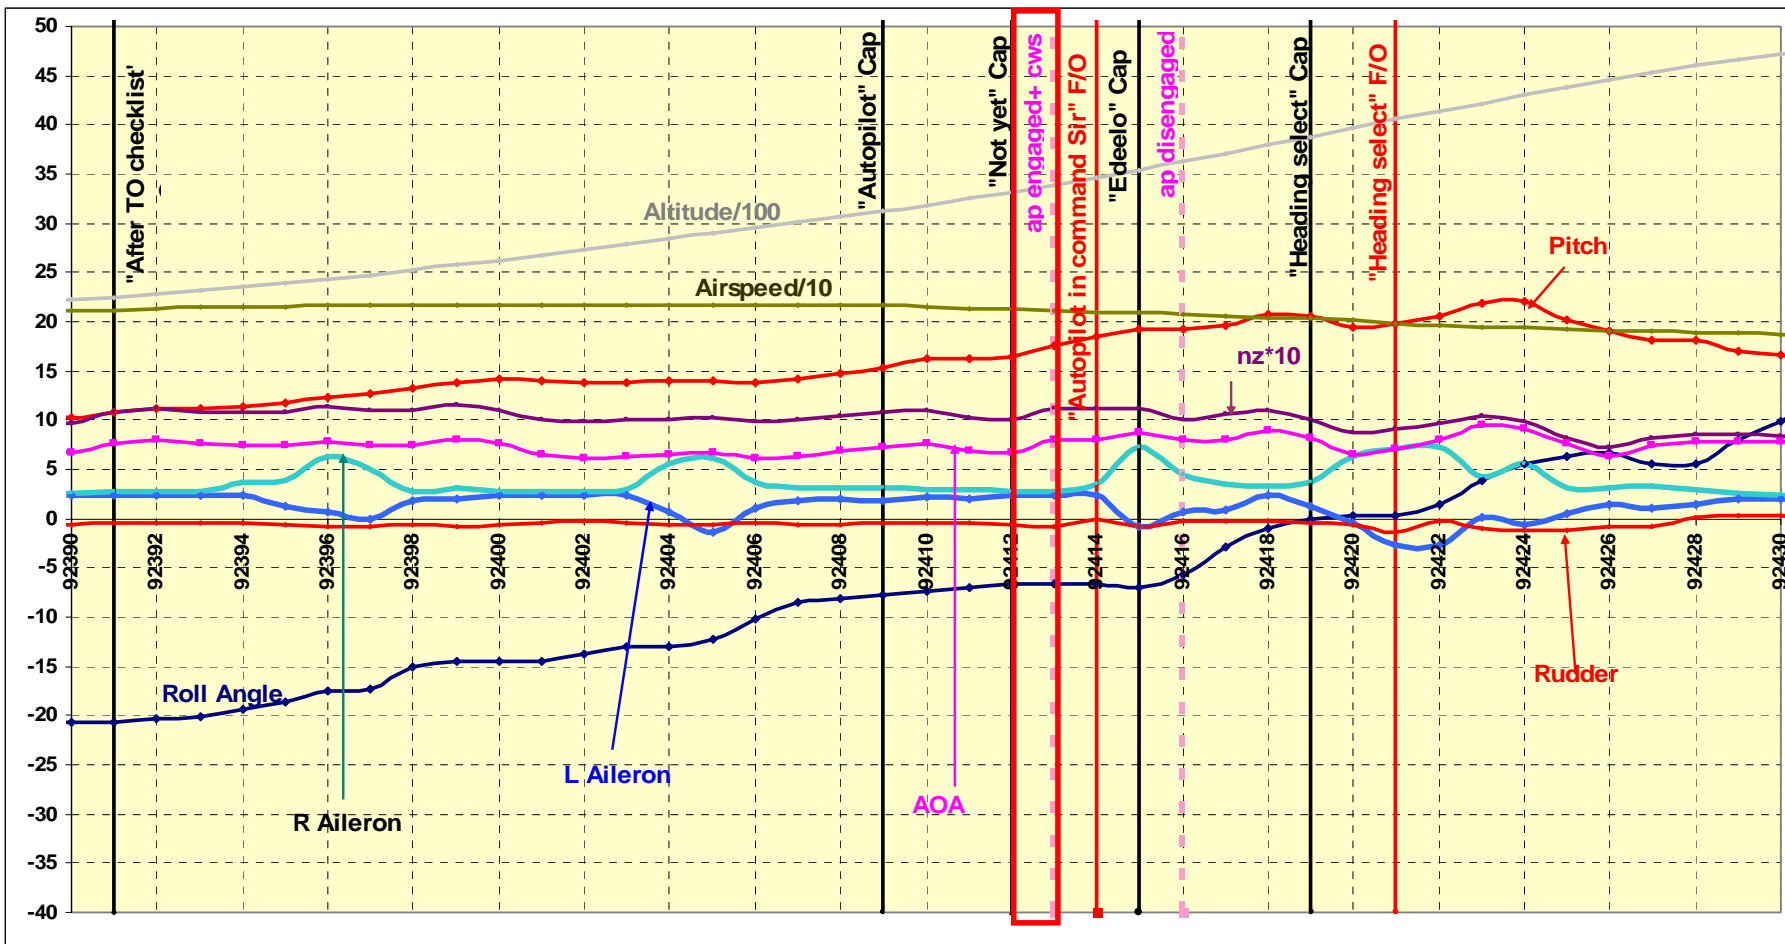
Figure 2.5.8 Mode change from HDG SEL to CWS-R

At 92413 FDR showed A/P engaged+ CWS-R

After ruling out the conditions which are unlikely to occur as mentioned above, the possible condition that could have led to this event is that the autopilot was Engaged with FD Roll Bar > 7 Degrees (with time lag)
